Samish Indian Nation
Department of Natural Resources

Continuous Temperature Monitoring in Fidalgo Bay
Year 1- Methods and First year Results

June 2009

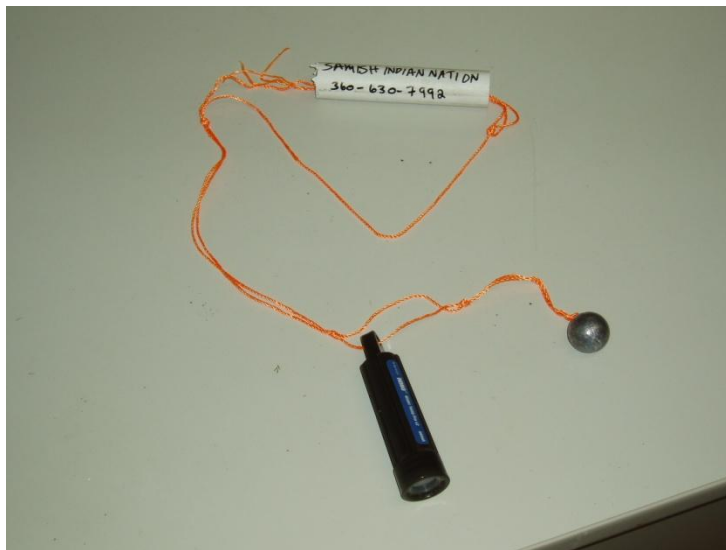
Figure 3: assembled sensor package prior to deployment. A fishing bobber was added to enhance visibility in eelgrass beds.

We used Onset Hobo continuous temperature monitors that had been calibrated in both a room temperature bath as well as a zero degree ice bath to insure that the sensors were reading accurately prior to deployment. They were then assembled in a sensor package that consisted of the datalogger, a piece of PVC pipe with contact information written on it, a weight to keep the sensor in place, and a bobber to allow for easy sighting of sensor package in eelgrass (Figure 3). During deployment, the location of each sensor was marked with a 5 foot piece of PVC pipe so that at low tides, they were clearly visible.

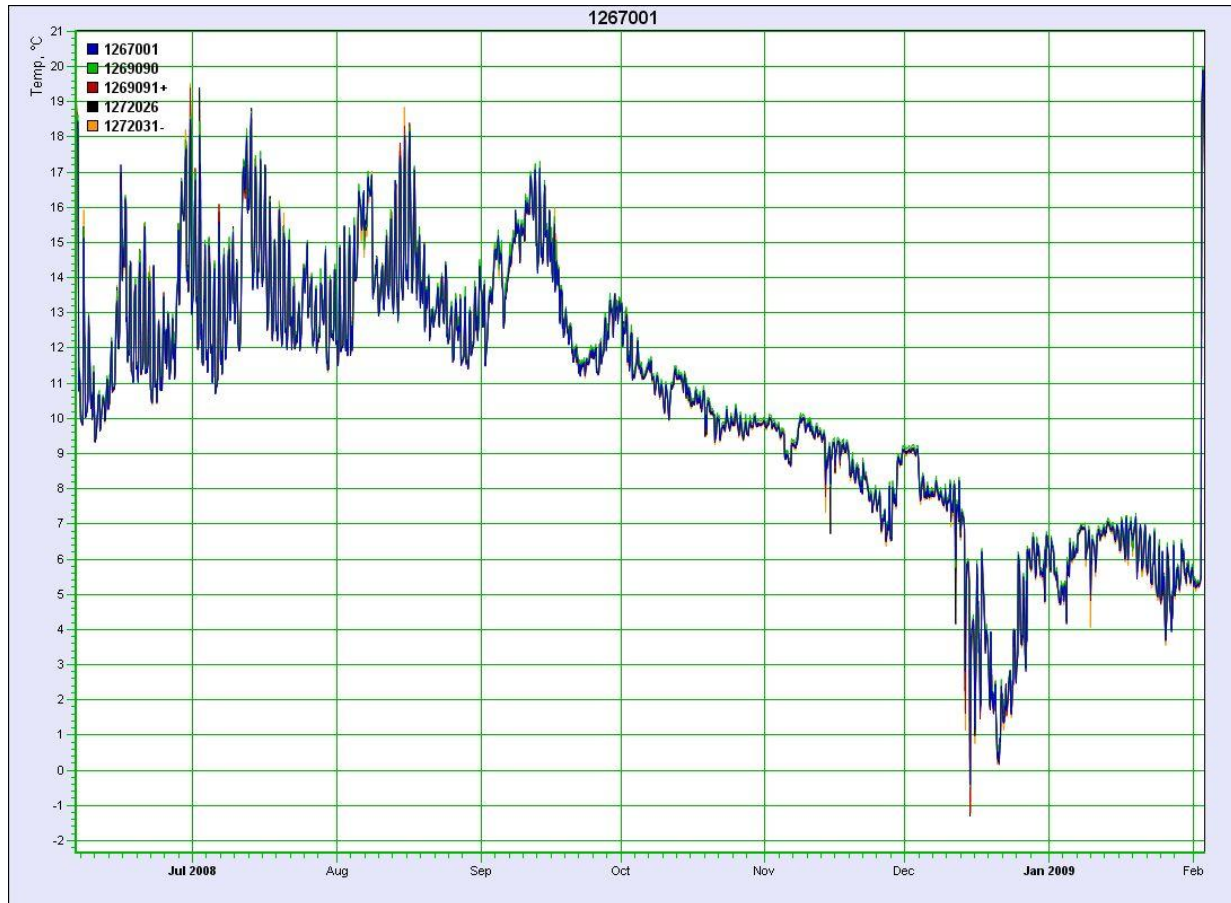
Figure 5: Group 2 sensor data comparison (raw hourly data sets).

Our first layer of analysis was to look at the variation between sensors within a single group. In this way, we could analyze whether sensors deployed in eelgrass beds showed a different temperature regime than those deployed in thin or no eelgrass. In each of the three groups, sensor data indicated very little difference in temperature regime inside and outside of eelgrass beds. Group 1 did not show as clean of a pattern. We suspect that this is due to the fact that sensors in this group were in the shallowest water and there were several times when some of the sensors were exposed. This has been confirmed by comparison to local ambient air temperature data and tide comparisons to be discussed later.

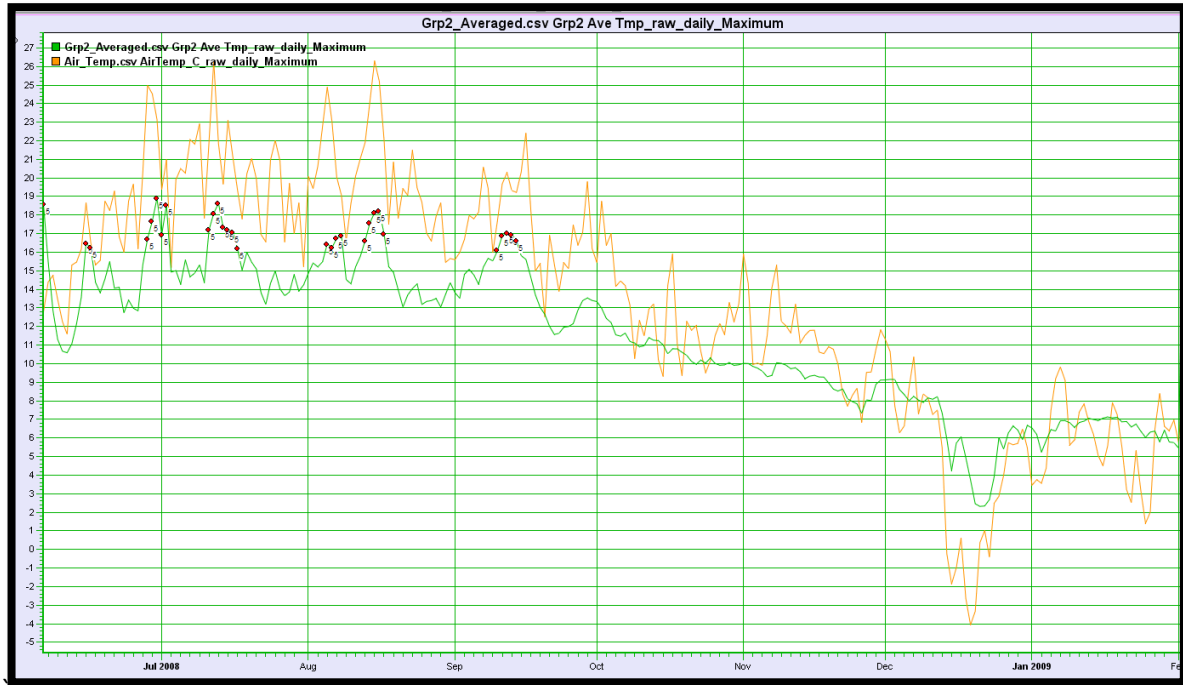
Figure 9: Group 2 daily maximum water temperature compared to daily maximum air temperature. Flags are located where the daily maximum water temperature exceeds Washington State standard of 16°C.

Group 2 recorded a total of 29 days where the daily maximum water temperature exceeded Washington State Standards between 6/6/08-9/30/08. This included a 5 consecutive day violation during the end of June into July, a 7 consecutive day violation in mid July, two separate 4 consecutive day violations in August and one 5 consecutive day violation in September.

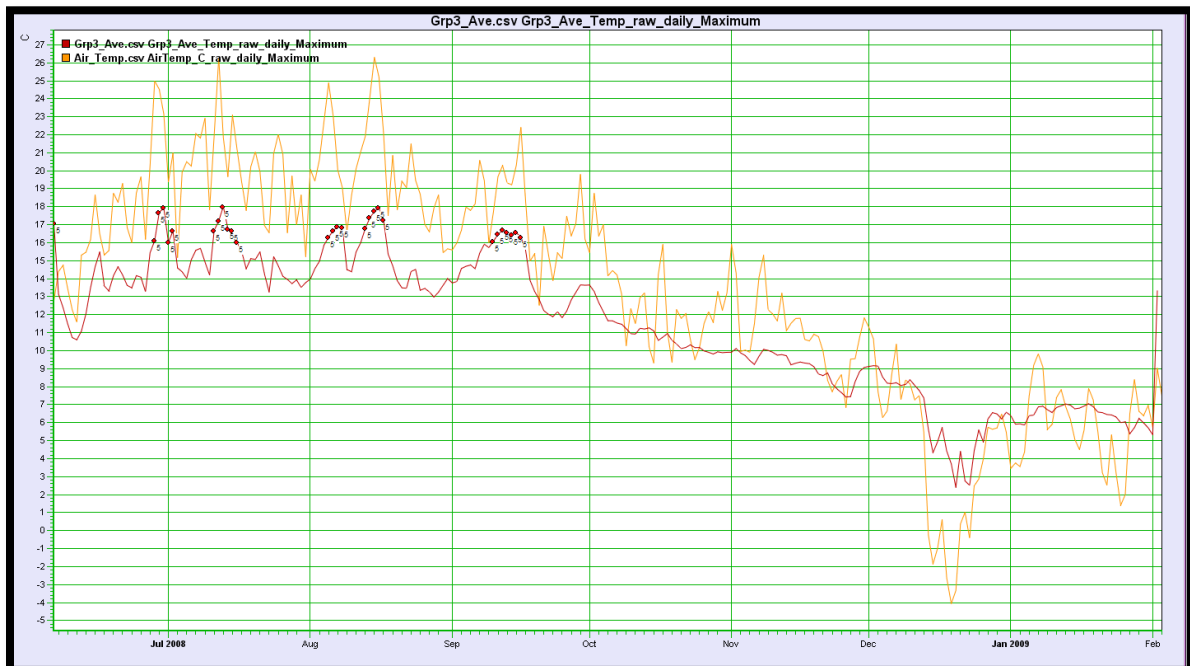
Figure 10: Group 3 daily maximum water temperature compared to daily maximum air temperature. Flags are located where the daily maximum water temperature exceeds Washington State standard of 16°C.

Group 3 recorded 28 days where the daily maximum water temperature exceeded Washington State Standards between 6/6/08-9/30/08. This included a 6 consecutive day violation in the end of June into

July, a 6 consecutive day violation in mid July , a 5 consecutive day violation and a 4 consecutive day violation in August (part of a 9 out of 13 consecutive days above state standards), and a 7 consecutive day violation in September.

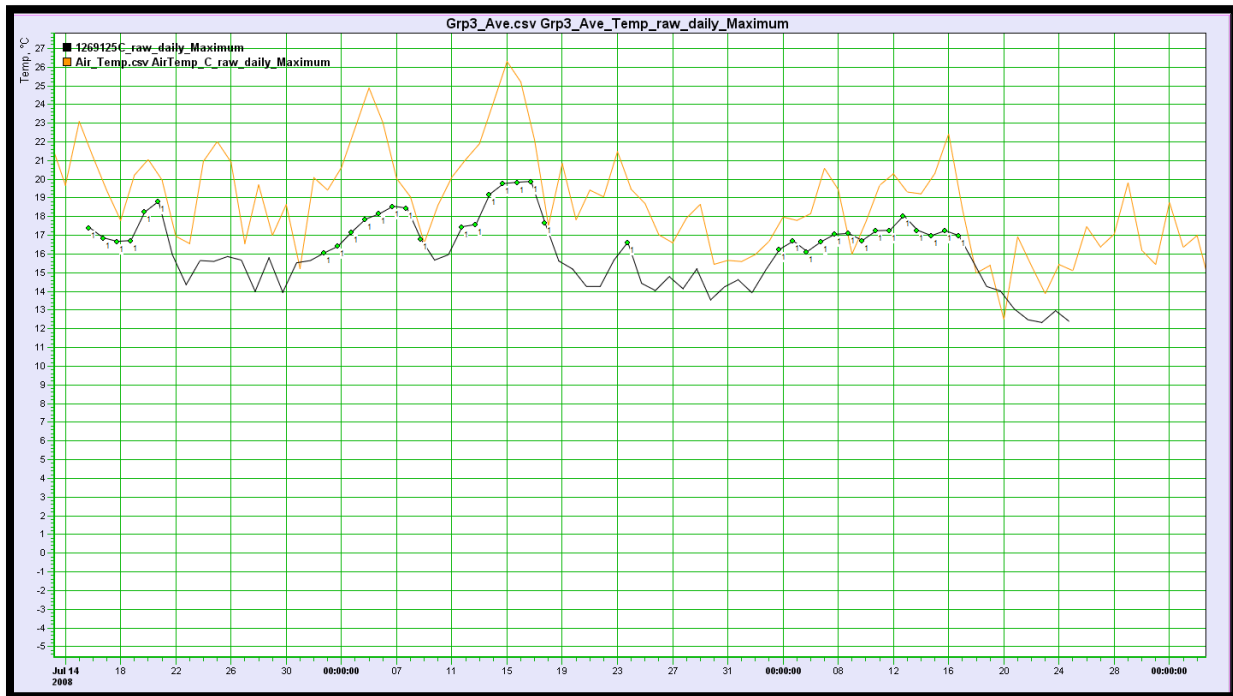
Figure 11: Causeway sensor daily maximum water temperature compared to daily maximum air temperature. Flags are located where the daily maximum water temperature exceeds Washington State standard of 16°C.

The deep water causeway sensor recorded 36 days out of only a 70 day deployment where the daily maximum water temperature exceeded Washington State Standards. This included a 5 consecutive day violation in July, an 8 consecutive day violation and a 7 consecutive day violation in August (totaling 15 out of 17 consecutive days), and a 14 consecutive day violation in September.
